Clean Air Act Compliance Inspection Report

Full Compliance Evaluation

Bristol Bay Fuels – Dillingham Downtown Terminal Dillingham, Alaska

Inspection Date: August 15, 2022

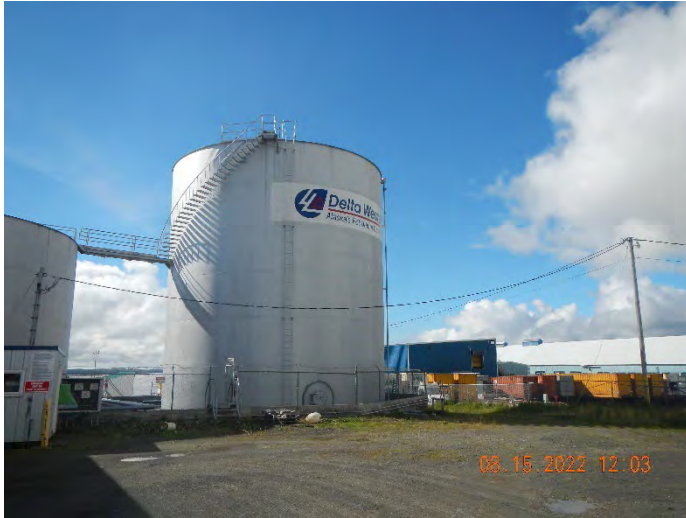
The Facility remains locked and gated for restricted access. According to Mr. Byrne, the Facility does continue to utilize Tank #11 for jet-a fuel storage (**Photo 1**), and is also storing small quantities of aviation gasoline, regular unleaded and #2 fuel oil within the tank farm.

Photo #:01 (DSCN2681)
Description: Facing south/southwest, photo of Tank #11.

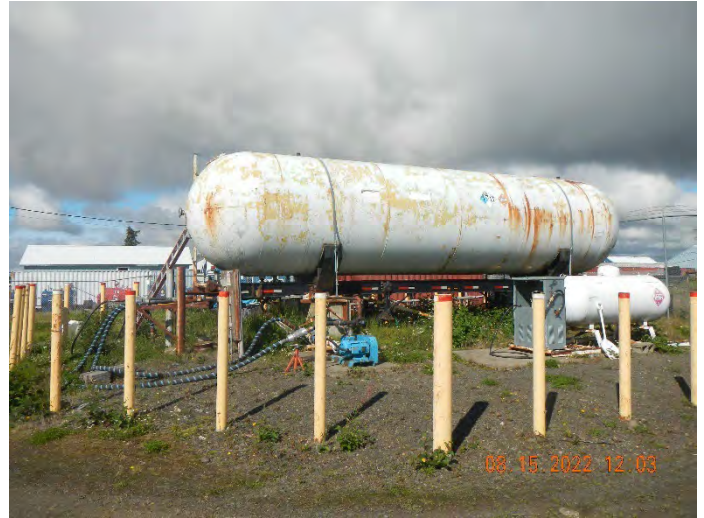
Current activities are limited to maintenance and repairs and occasional access to supply the neighboring business (Peter Pan Seafoods) with propane from the Facility’s large onsite propane tanks (**Photo 2**). Mr. Byrne also stated that the Facility hopes to have their adjacent gas station back in service within the next year.

Photo #:02 (DSCN2682)
Description: Facing west, photo of propane tanks on-site.

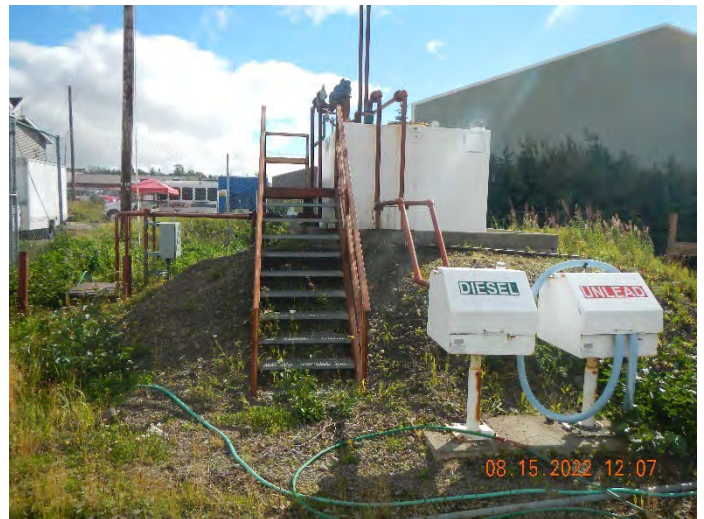
After viewing the truck loading rack, we then toured two above-ground gasoline/diesel storage tanks (**Photo 4**) that are used to supply the adjacent gas station when in service. Both the truck loading rack and the gasoline storage tanks were observed with the FLIR GF320 gas detection camera. No vapors/leaks were observed from the equipment gaskets/seals.

Photo #:04 (DSCN2684)
Description: Facing east, photo of storage tanks used to supply gas station.

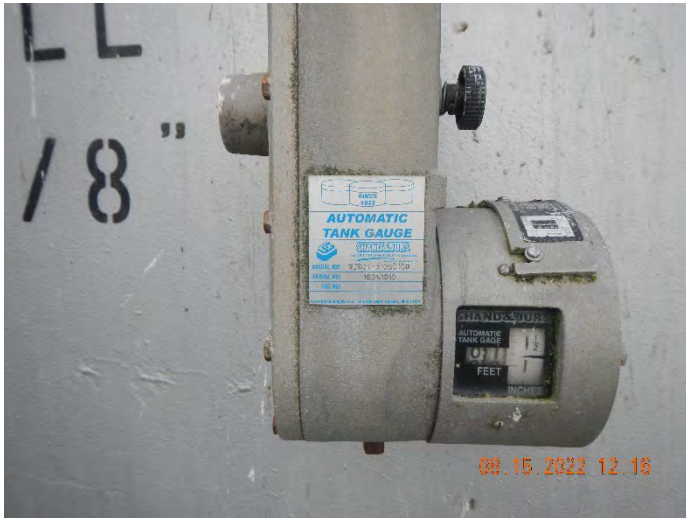
We first toured the tank farm from ground level, beginning at Tank #1 which had a minimal amount of aviation gasoline product as indicated on the tank gauge (**Photo 5**). We observed the gasket/seals on each tank using the FLIR GF320 gas detection camera, no vapors or leaks were observed. Each gasket/seal appeared to be in working order. Mr. Byrne stated that typically brownish staining or a sheen below is indicative of a minor leak. As indicated earlier in this report, routine Facility inspections are documented on weekly and monthly checklists (**Attachment D**).

Photo #:05 (DSCN2685)
Description: Tank #1 gauge.

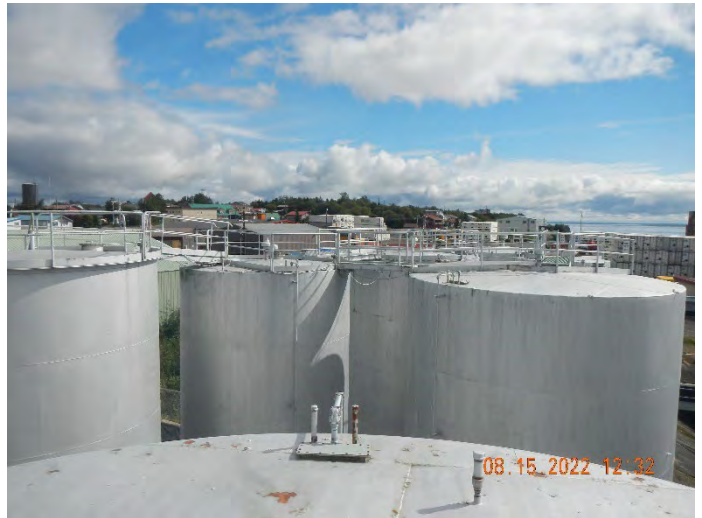
We then observed the top of the tanks via the connecting bridges/walkway above (**Photo 6 & Photo 7**), this included observing each tank's pressure relief valve and vent. Looking at the top of the tanks with the naked eye, I did not see any vapors. However, using the FLIR GF320 gas detection camera, vapors were observed coming from the vent/valve in Tank #1 and Tank #11 (**Video 1 – Video 3**). Using the camera's view finder, Mr. Byrne also viewed select vent/valves. Mr. Byrne was not aware of current pressure release settings on the valves or any recent calibration and/or service. It was discussed that venting at Bulk Plants is not prohibited under Part 63 NESHAP Subpart BBBBBB.

Photo #:06 (DSCN2686)
Description: Facing east, photo of the tank farm from the top of Tank #8.

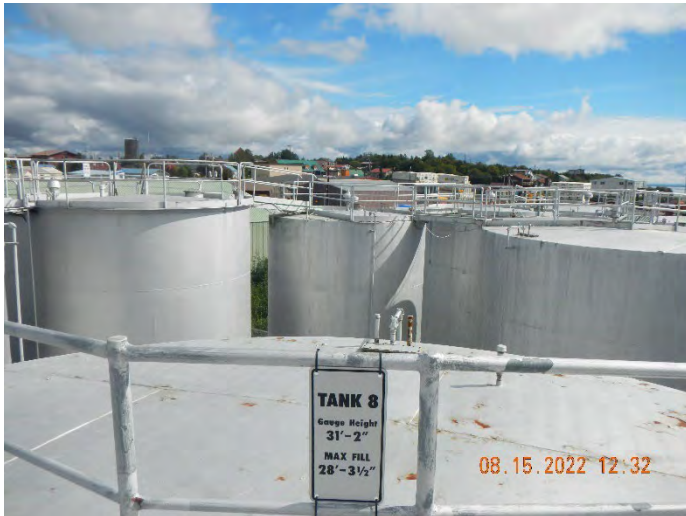
Photo #:07 (DSCN2687)
Description: Facing east, photo of the top of Tank #8 and tank farm in the background.

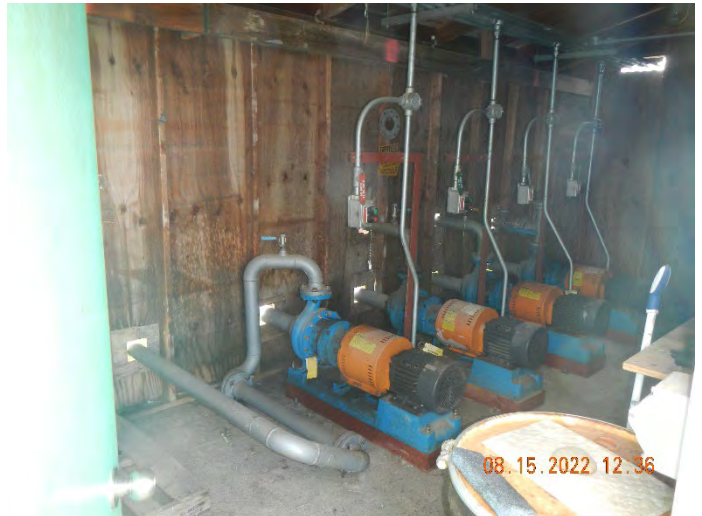
After viewing each tank from above, we exited the tank farm and toured the Facility's pump room (**Photo 8**); within the pump room a series pumps are used to supply fuel from the tank farm to the truck loading rack. Using the FLIR GF320 gas detection camera, no vapors/leaks were observed from the equipments gaskets/seals within the pump room.

Photo #:08 (DSCN2688)
Description: Photo of inside the pump room.

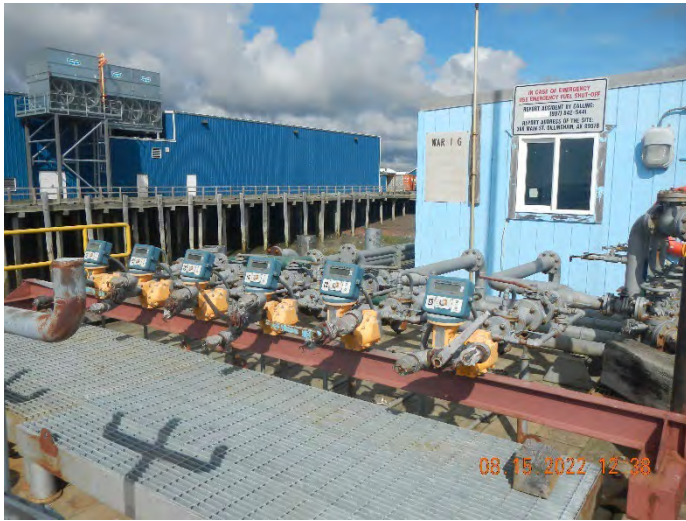
We then traveled south along the dock and observed the marine loading rack (**Photo 9**) which is used to provide fuel to the marine fishing vessels during the summer months/fishing season. We also viewed the marine cargo input location (**Photo 10**) used to supply product to the Facility via barge. I observed both the marine loading rack and marine cargo input location using the FLIR GF320 gas detection camera, no vapors/leaks were observed from the marine loading rack equipment. We concluded the tour back at the truck loading rack (**Photo 11**) to further observe the drop tube/downspout equipment (**Photo 12**).

Photo #:09 (DSCN2689)
Description: Facing north, photo of the marine pump lines.

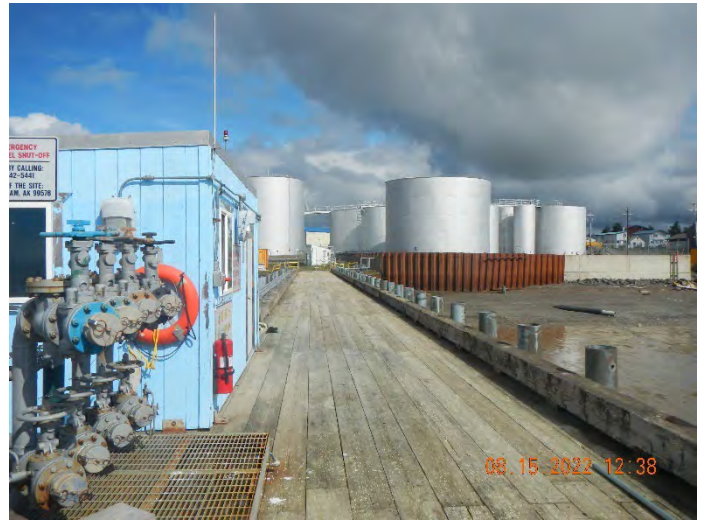
Photo #:10 (DSC2690)
Description: Facing north, photo of the marine intake lines.

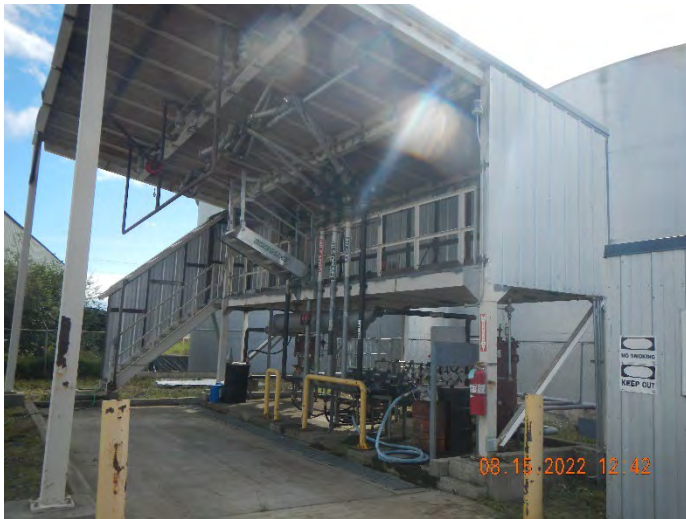
Photo #:11 (DSCN2691)
Description: Facing east, photo of the truck loading rack.

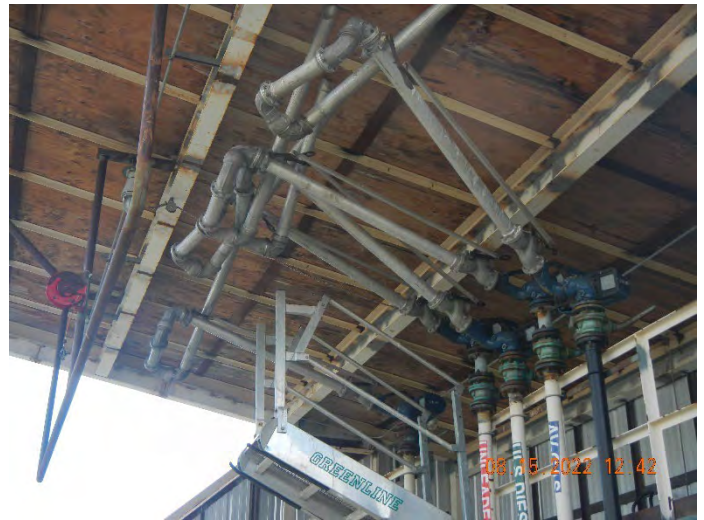
Photo #:12 (DSCN26792)
Description: Facing east, photo of the drop tube /downspouts at the truck loading rack.
